State of Nevada
Department of Administration
Public Works Division – Building and Grounds Section
Stewart Campus
Facility Condition Analysis

Site Number: 9971
STATE OF NEVADA PUBLIC WORKS DIVISION
FACILITY CONDITION ANALYSIS

Report Printed in December 2013

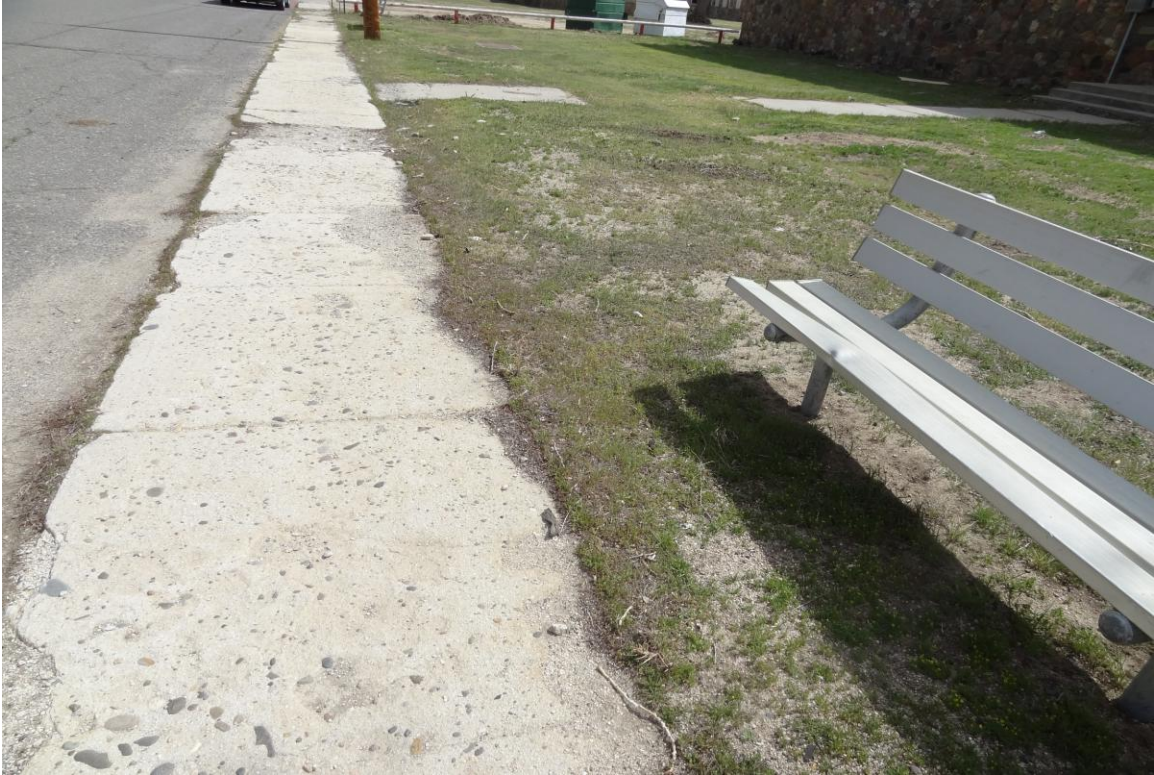
Some of the sidewalks serving the buildings and recreation areas on this site are deteriorated and failing. In some areas cracks wider than four inches have been identified, and there is settling in many locations. This project addresses removal and replacement of existing sidewalks as needed. 10,000 SF of 4" thick concrete sidewalk was used for this estimate.

Stewart Campus Site – FCA Site #9971
Description: Walkway in front of building #102.

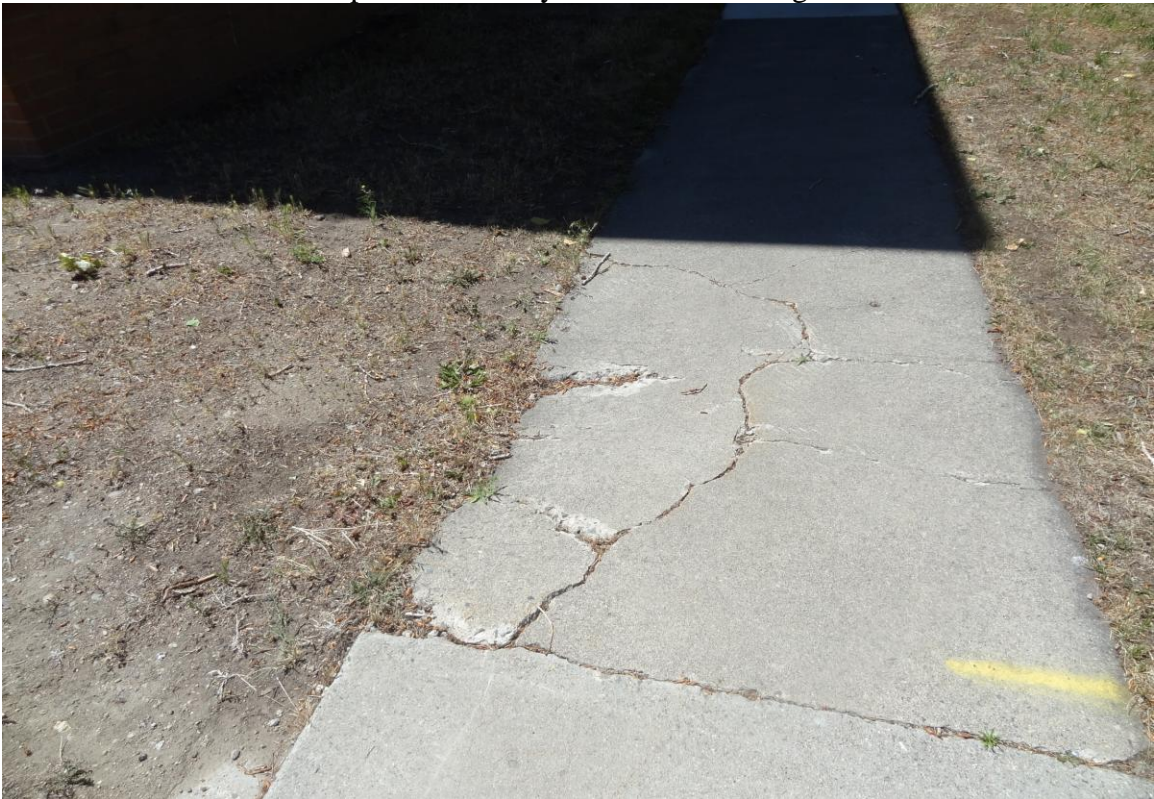
Stewart Campus Site – FCA Site #9971
Description: Damaged concrete walkway.

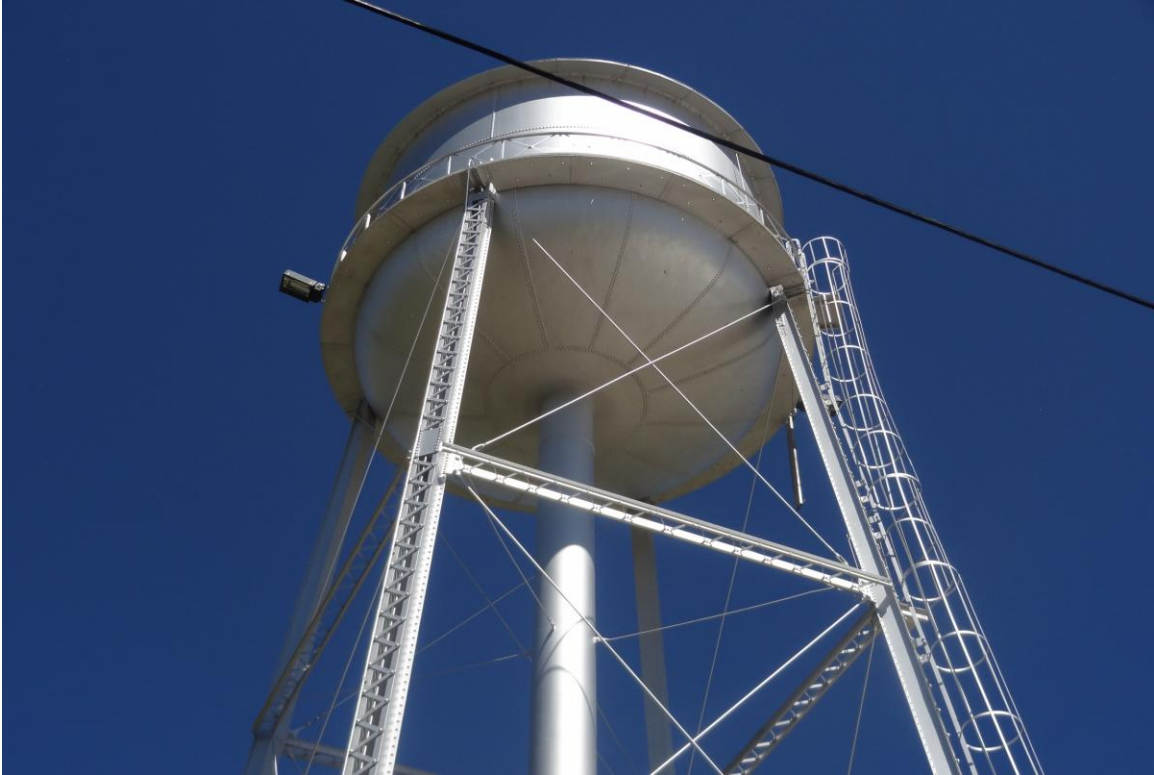
Water Tower – FCA Building #2704
Description: View of the tower.

It is important to maintain the finish, weather resistance and appearance of the water tower. This project would provide for the painting of the water tower and caulking of the joints to maintain it in a good, weather tight condition. It is recommended that this project be implemented in the next 2-3 years and is recommended on a cyclical basis based on environmental conditions.

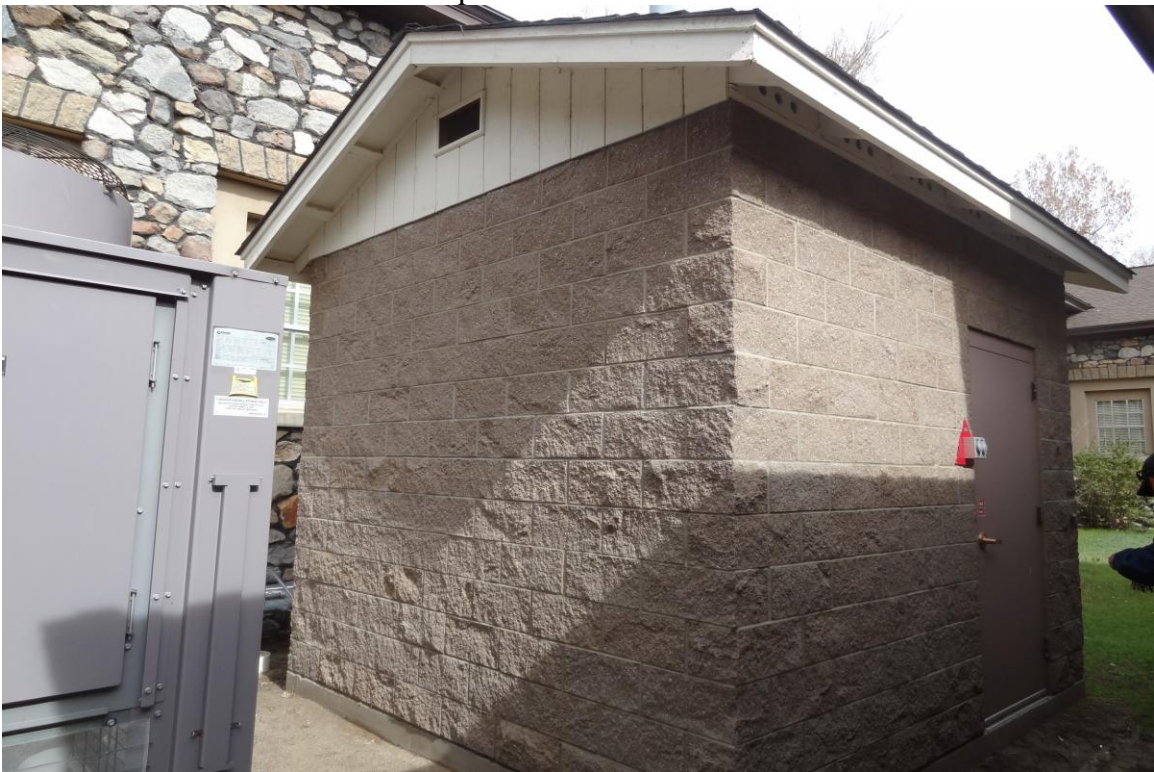
Building #89 Utility Room – FCA Building #2703
Description: Exterior of the building.

The Utility Room building is located in the courtyard of Building 89. It is a concrete masonry unit and wood framed structure which houses the mechanical equipment for the building. The building has an asphalt composition roofing system and a concrete slab-on-grade foundation. It is in good condition.

The interior finishes are in fair condition. It is recommended that the interior CMU walls be sealed at least once in the next 2-3 years and that this project be scheduled on a cyclical basis to maintain the integrity of the structure.

It is important to maintain the finish, weather resistance and appearance of the building. This project would provide funding to protect the exterior of the building excluding the roof. Included in the cost are painting the wood finishes, cleaning and sealing the concrete masonry units and caulking of the flashing, fixtures and all other penetrations. It is recommended that the building be sealed and caulked in the next 2-3 years and that this project be scheduled on a cyclical basis to maintain the integrity of the structure.

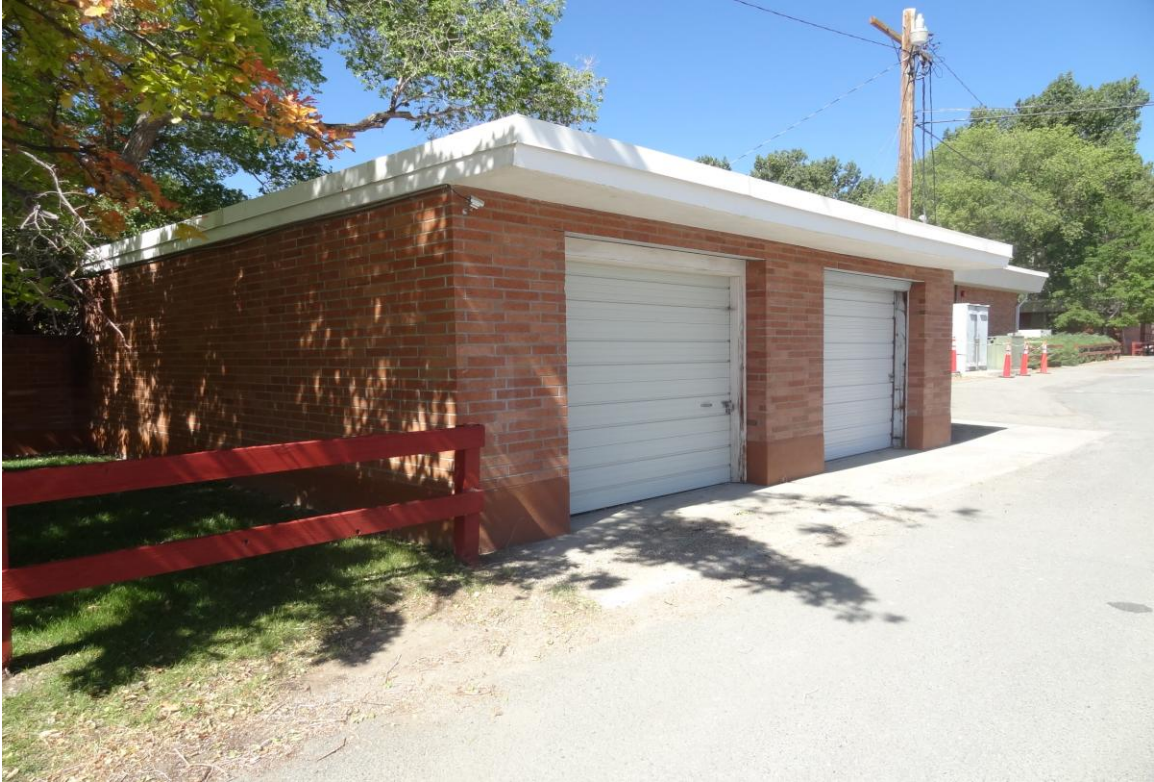
Building #107 - Garage – FCA Building #2702
Description: Exterior of the building.

Building 107 Garage is a brick masonry structure with a low slope single-ply roofing system on a concrete slab-on-grade foundation. It is located along the north side of Building 107 and is in good shape.

The interior finishes are in fair condition. It is recommended that the interior walls and ceilings be painted at least once in the next 2-3 years and that this project be scheduled on a cyclical basis to maintain the integrity of the structure. Prior to painting, all surfaces should be repaired and prepped.

It is important to maintain the finish, weather resistance and appearance of the building. This project would provide funding to protect the exterior of the building excluding the roof. Included in the cost are cleaning and sealing the brick masonry, painting the concrete roof eaves and caulking of the flashing, fixtures and all other penetrations. It is recommended that the building be sealed, painted and caulked in the next 2-3 years and that this project be scheduled on a cyclical basis to maintain the integrity of the structure.

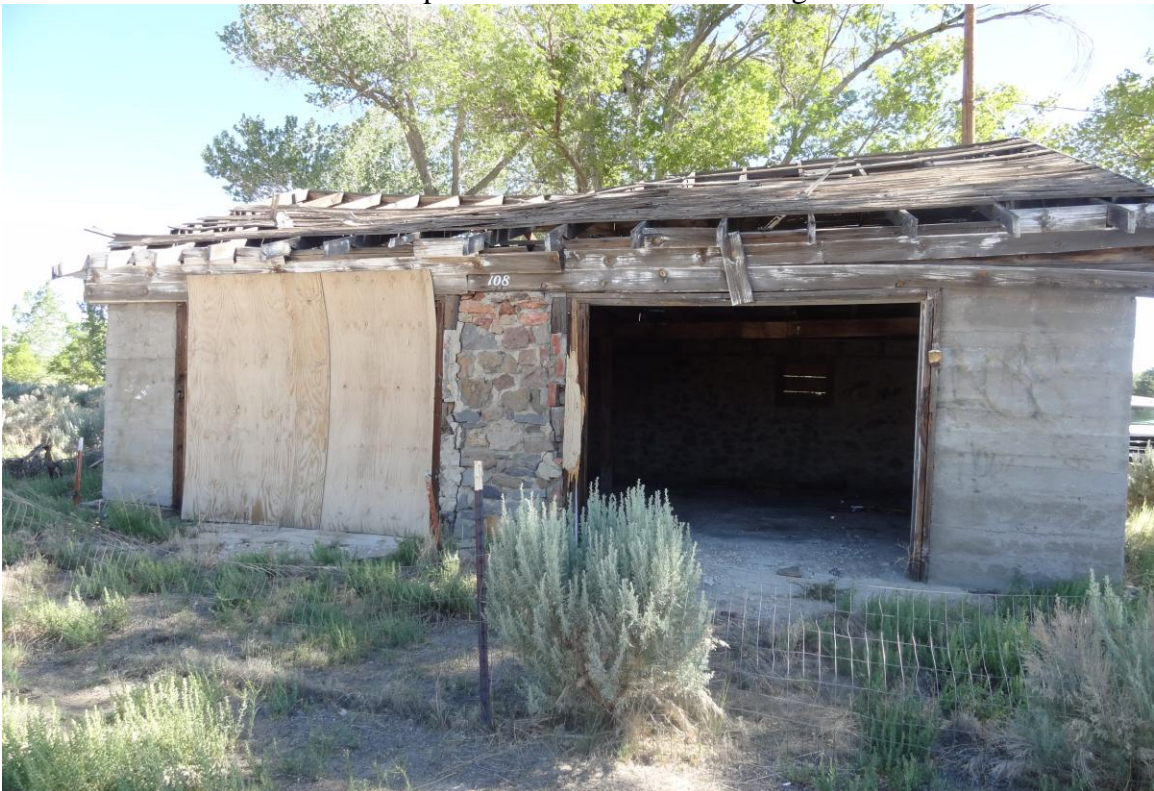
Building #108 – Garage (Vacant) – FCA Building #2163
Description: Exterior of the building.

Building No. 108 is an unreinforced stone masonry and wood framed structure located at the south end of the Stewart Complex. This building is in extremely poor condition and is showing signs of possible structural collapse. These issues will be addressed with a project recommendation in the report.

The building is an old garage that is no longer in use. It has significant structural failures and the roof is completely deteriorated. It is recommended that this structure be demolished.

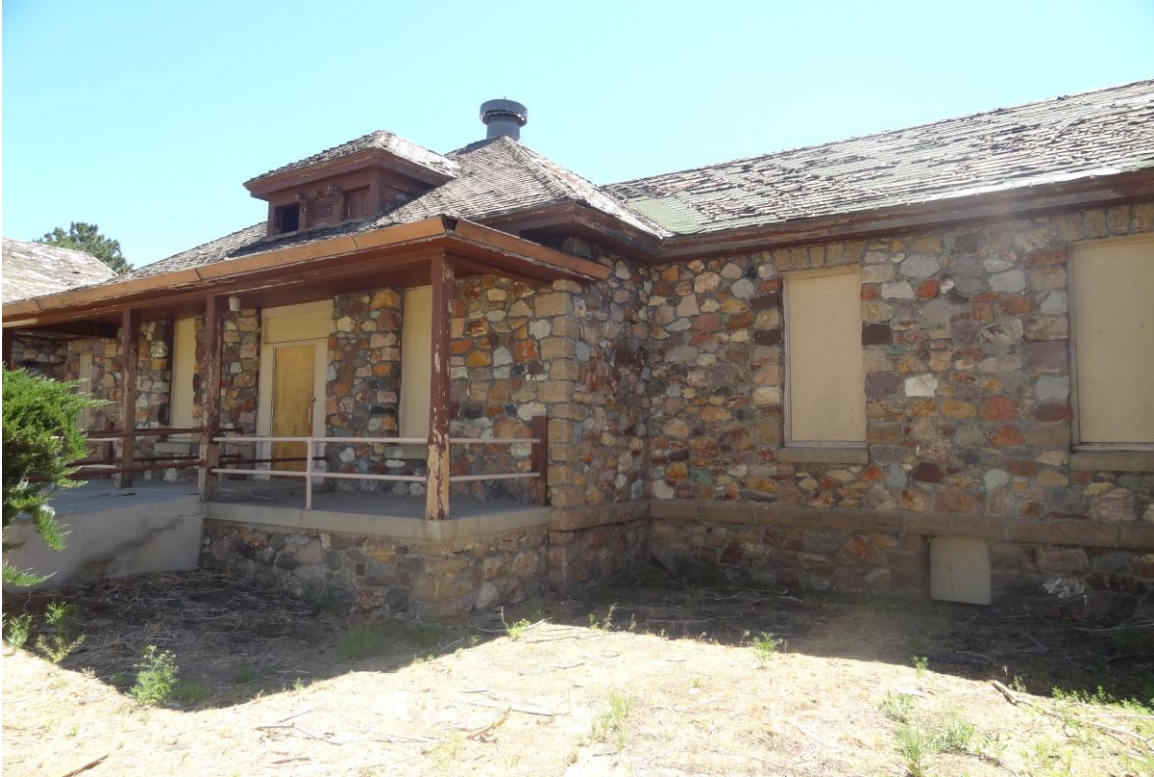
Building #102 – Infirmary (Vacant) – FCA Building #2162
Description: Exterior of the building.

Building No. 102 is an unreinforced stone masonry and wood framed structure located at the southeast end of the Stewart Complex. This building is in poor condition. It is currently (2013) not occupied and there are no plans for future occupation.

The asphalt composition shingle roof on this building was in poor condition at the time of the survey with active leaks and animals living inside. It is recommended that this building be re-roofed in the next 2-3 years with a new 50 year asphalt composition roofing shingle and new underlayments. This estimate includes removal and disposal of the old roofing.

In order to preserve the building for future rehabilitation and reuse, this project recommends mothballing it in accordance with the U. S. Department of Interior Recommended Guidelines in Preservation Brief 31. Costs related to removing water in the basement, providing drainage away from the building to prevent future water accumulation, pest control and removal of accumulated waste are included. Windows and doors will be secured or covered, and some will include louvers to permit ventilation of the structure.
